9. SEISMIC BEHAVIOUR, VULNERABILITY AND PROBABILITY OF COLLAPSE OF MASONRY BUILDINGS

9.1 Introduction

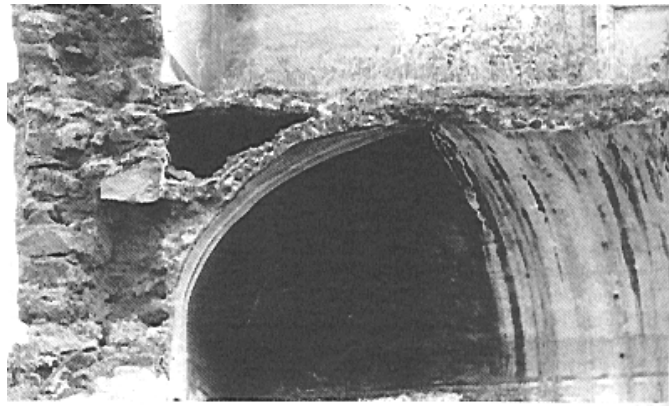
Figure 9.6 - Vault and counter-vault in pumice-stone and plaster (Randazzo, 1988).

H2) Vaults. The vaults in pumice-stone and plaster (Fig. 9.5) represents the most frequent type in the historical centre (Arezzo, 1994). Their span length ranges from 4 to 6 m. The key thickness is 8÷12 cm. Sometimes, the fill is replaced by counter-vaults (Fig. 9.6).

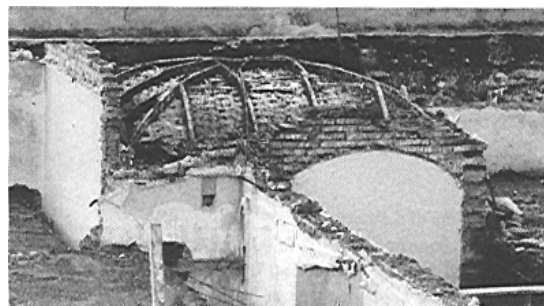
Figure 9.9 - Upper surface of a “false” vault (Randazzo, 1988).

Two types of roof are present: saddle roofs and flat roofs. Saddle roofs are in chestnut-wood (Fig. 9.8). Under the roof, there are “false” vaults in canes and plaster with wooden frame, without any structural function (Fig. 9.9). Flat roofs are in wood or in steel beams.

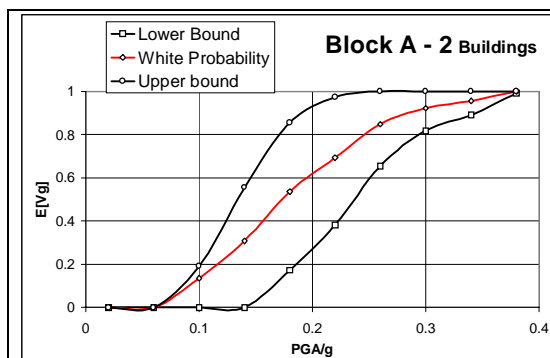
Figure 9.20 - Building block A of via Verdi / via Capuana: expected value of vulnerability, average for the two interacting parts.

For example Figures 9.20-21 gives $E[V_g]$ for the blocks A and B (see sub-sect. 9.4), each one subdivided into two interacting buildings. For both blocks, the following characteristics of the walls have been assumed: average compression strength = 3 MPa (justified by results of flat jacks tests), density = 2300 kg/m³, average tensile strength = 0.20 MPa (1/15 of compression strength, justified by the good quality of the mortars).

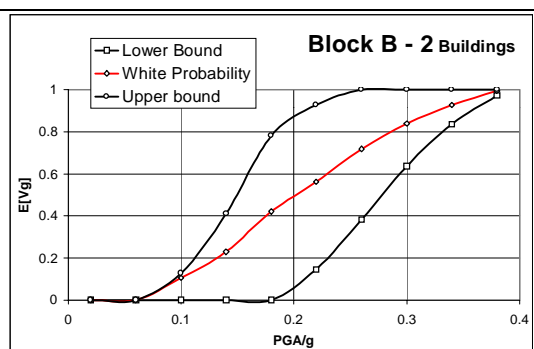
Figure 9.21 - Building block B of via Martoglio: expected value of vulnerability, average for the two interacting parts.

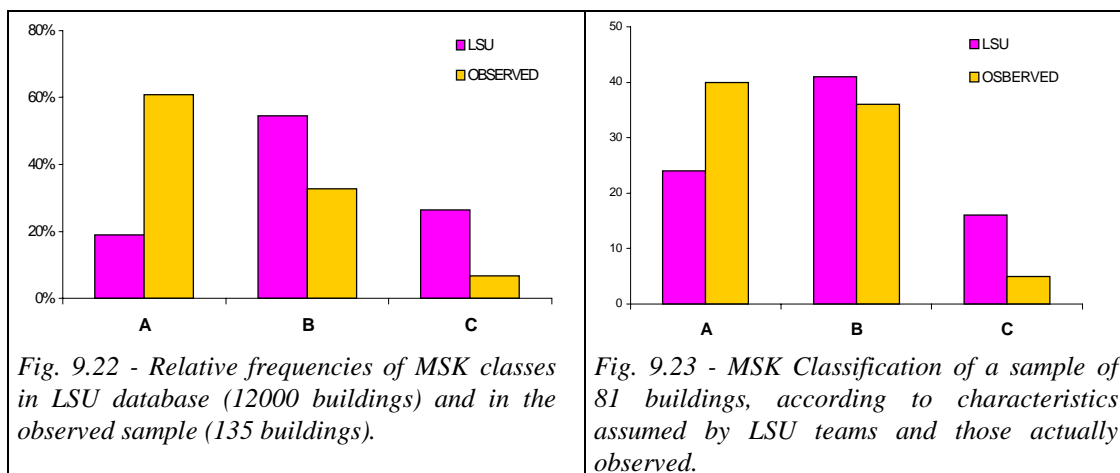
The resulting classification is shown in Figure 9.22, where the large differences of the relative frequencies in the LSU database and in the observed sample appear clearly. In Figure 9.23 an homogeneous comparison is shown for 81 buildings respectively as recorded in LSU database and observed in the survey. It seems that such a considerable difference could be mainly due to inconsistent recording of the structural types in LSU database, as documented in the survey, particularly for the horizontal structures.

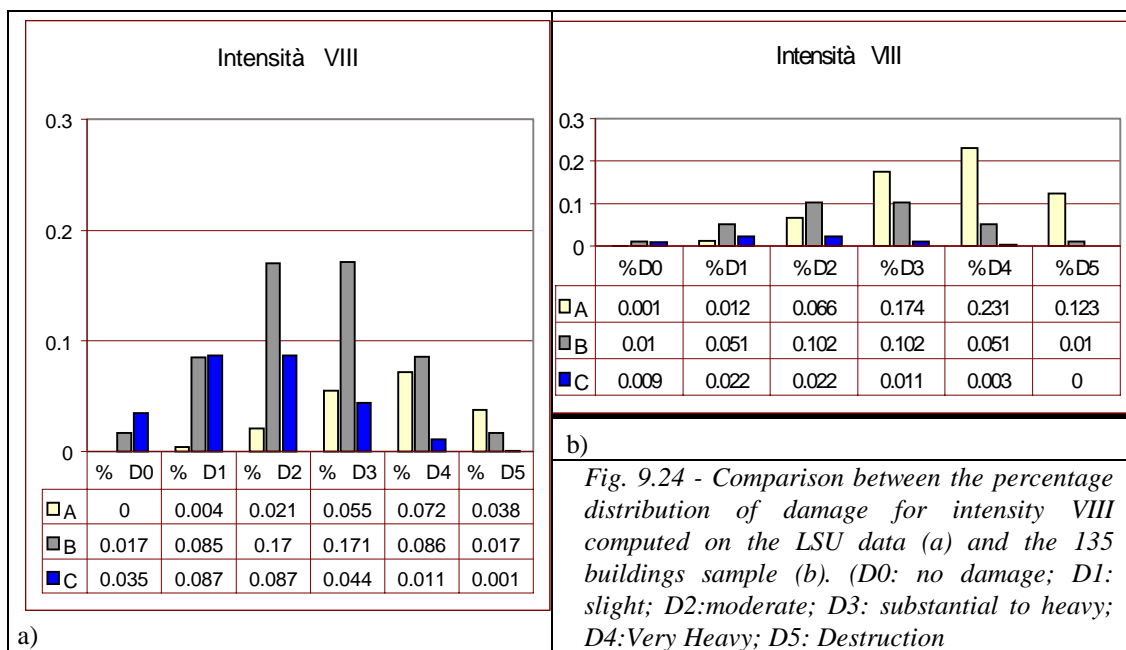
Fig. 9.24 - Comparison between the percentage distribution of damage for intensity VIII computed on the LSU data (a) and the 135 buildings sample (b). (D0: no damage; D1: slight; D2: moderate; D3: substantial to heavy; D4: Very Heavy; D5: Destruction)

In Figures 9.24 and 9.25 the damage distributions (ratio of the frequencies to the total number of buildings), for the overall building stock (LSU database:12000 buildings) and for two different MSK intensities, are illustrated and compared with the percentage of damage derived by using the sample of the 135 buildings.

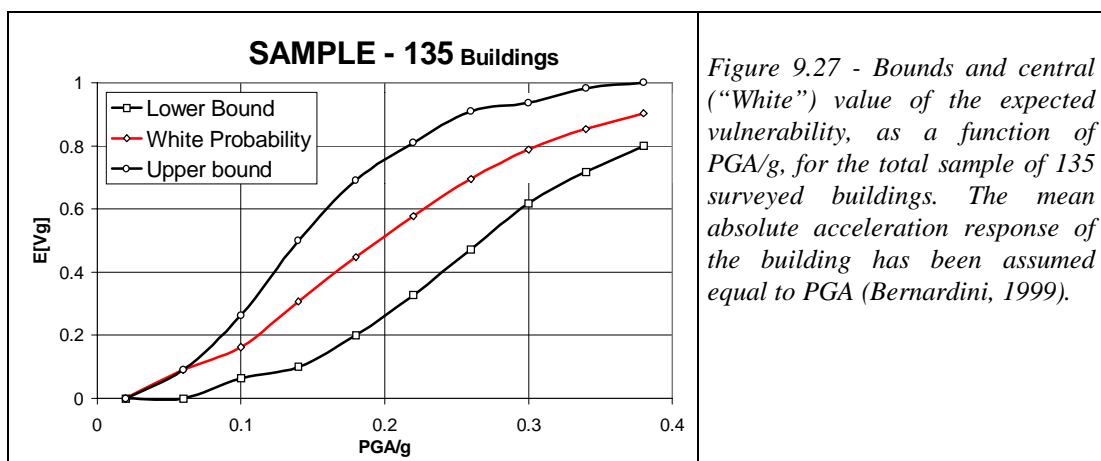
Figure 9.27 - Bounds and central ("White") value of the expected vulnerability, as a function of PGA/g , for the total sample of 135 surveyed buildings. The mean absolute acceleration response of the building has been assumed equal to PGA (Bernardini, 1999).

In Figure 9.27 the calculated upper and lower bounds of V_g are shown for the overall sample of 135 buildings: for the higher intensity (mean $PGA/g = 0.30$ in the town) V_g should be in the range $[0.60, 0.90]$, while Figure 9.25 gives 0.925 (more specifically 0.322 for D4, 0.563 for D5) for the sample, 0.775 for the LSU database; for the lower intensity (mean PGA/g in the town nearly equal to 0.20) V_g is in the range $[0.25, 0.70]$, while Figure 9.24 (IMSK = VIII) gives 0.418 for the sample, 0.225 for the LSU database. This second scenario does not seem to be consistent with the recorded value of IMCS = VII for the 1818 event, see sub-sect. 1.2.
