The recent Molise-Puglia seismic event (31 October, ML=5.4, and 1 November 2002, ML=5.3) damaged two similar, adjacent, R/C buildings, (Figure 1) located outside the historic down town of Bonefro and realised in the early '80 by Istituto Autonomo Case Popolari (IACP). Although at the time of design Bonefro was not considered seismic area, both buildings were designed according to the current seismic code. This did not avoid damage to the buildings during the first shock and a considerable increase of damage during the second shock (Figure 3 and Figure 4). The buildings, that are very similar in plan, differ in height. The most damaged one is 4 story high. Heavy damage has been observed in the infill walls and columns of the 1st story (Figure 2), while minor damage has been observed in the upper floors. The adjacent building is only 3 story high and suffered minor damage to the infill walls of the 1st story and apparently no damage to structural elements. The different behaviour of the two buildings, the damage accumulation due to repeated shocks, the high damage compared to the felt macroseismic intensity in Bonefro and the large amount of data collected, including in situ tests an

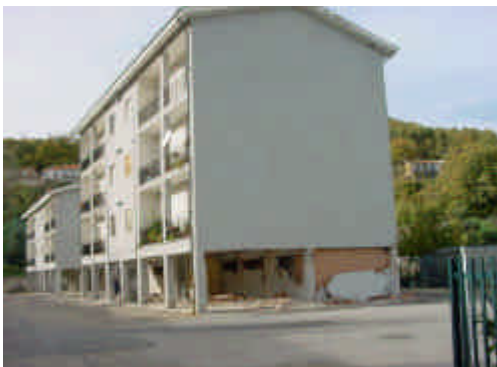
Figure 1. View of the buildings. (photo: S. Kodama)

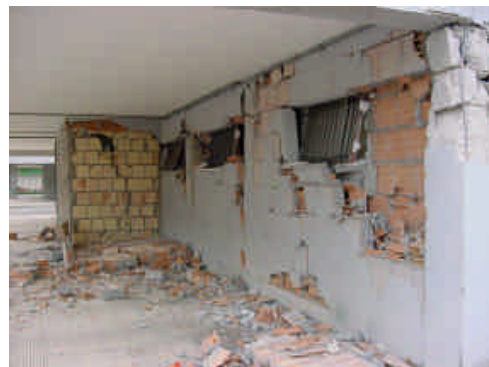
Figure 2. Damage to the columns of the 4 story building after the 2nd shock (photo: P.Bazzurro)

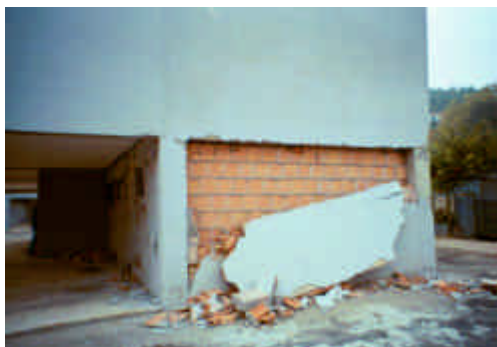
Figure 3. Damage to the 4 story building after the 1st shock (photo: M. Mucciarelli)

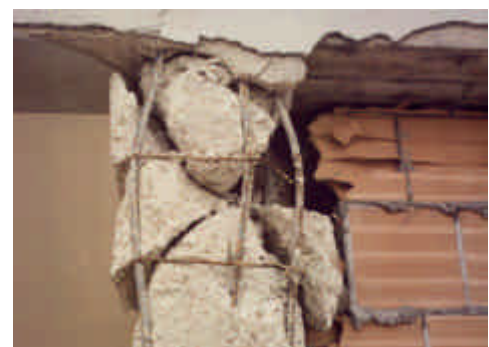
Figure 4. Damage after 2nd shock (same column as in figure 3) (photo: A. De Sortis)
